COASTAL GEORGIA  
**HISTORICAL  
SOCIETY**

**2025 Annual Report**

# Preservation Projects

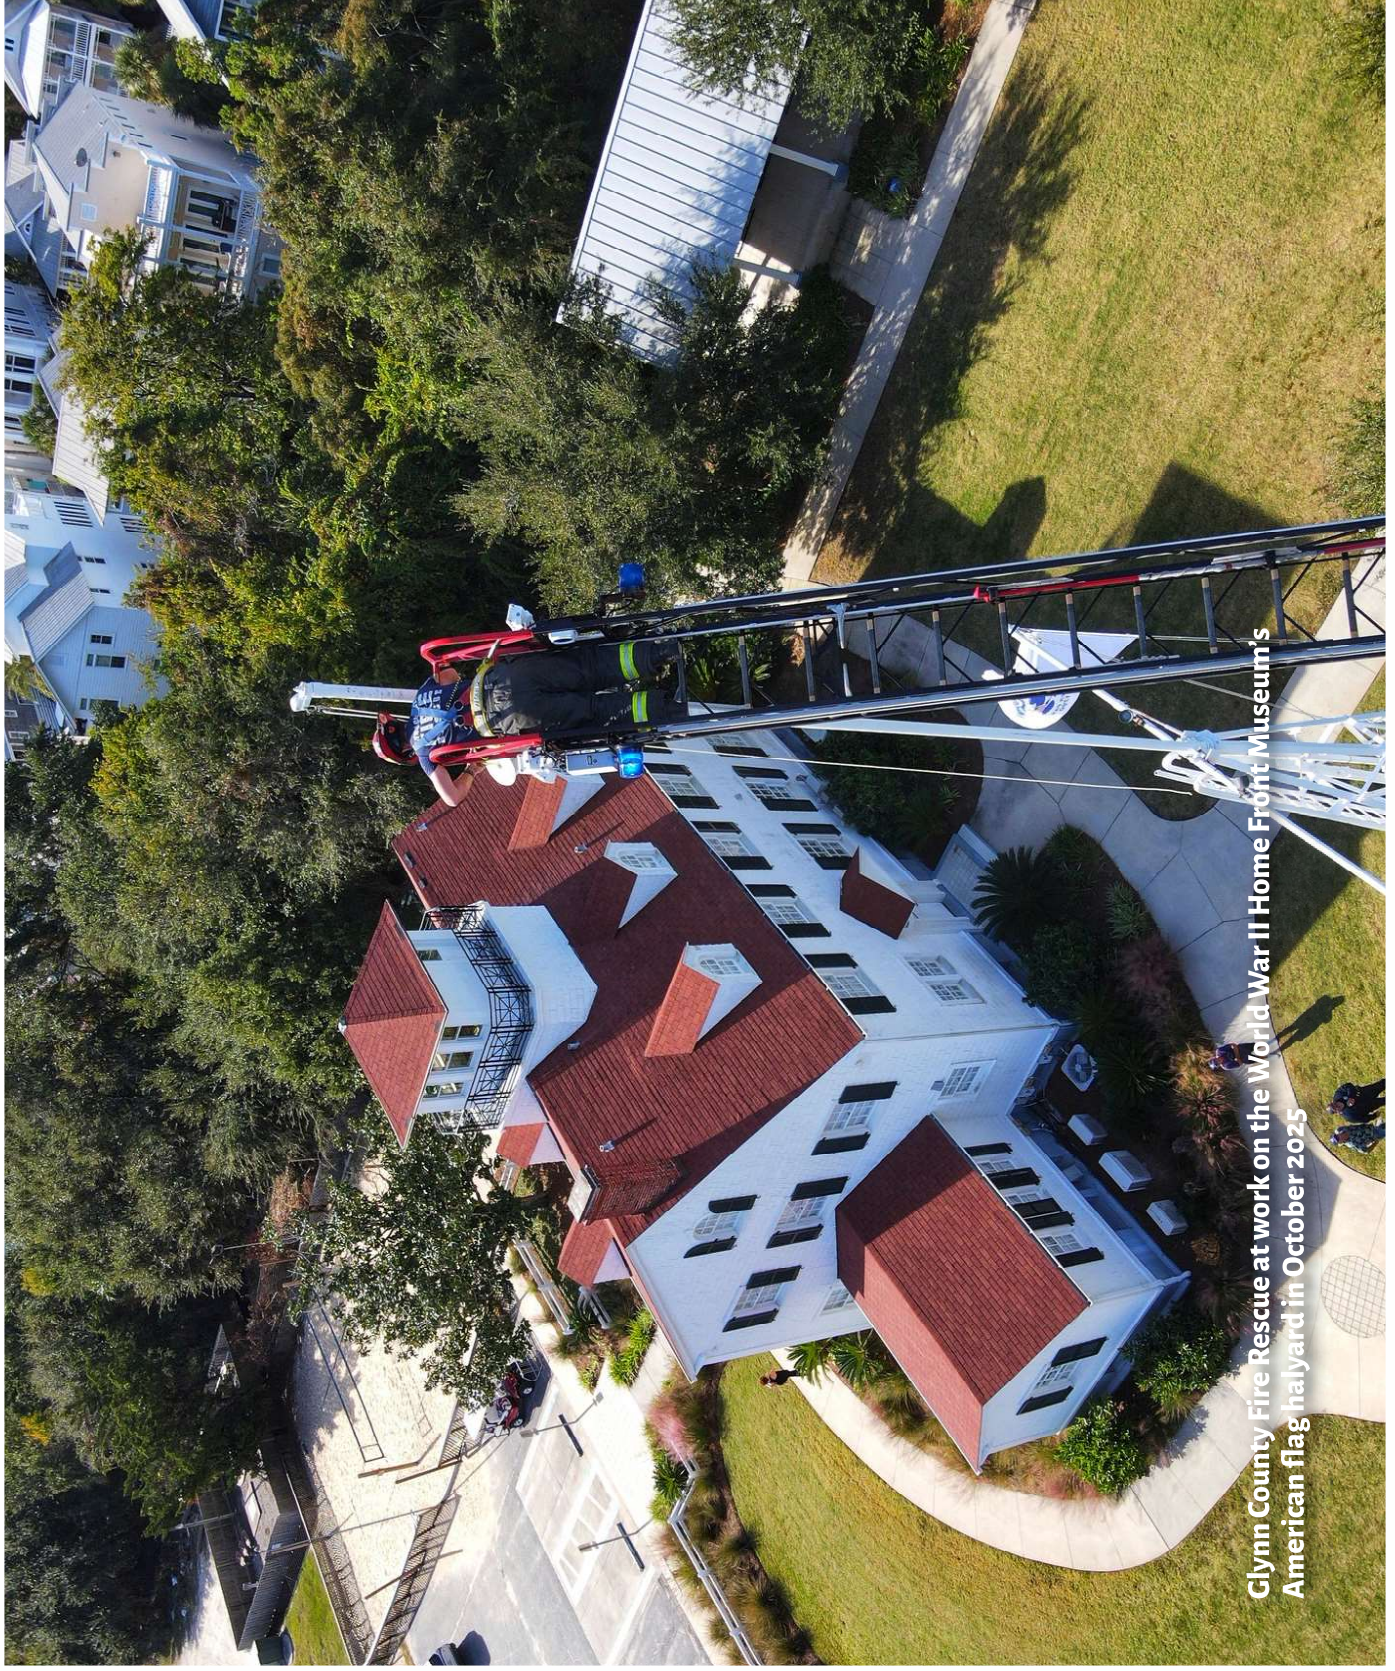
Glynn County Fire Rescue at work on the World War II Home Front Museum's American flag halyard in October 2025

■ In October, the **American flag halyard**, or rope hoisting mechanism, broke on the World War II Home Front Museum's flagpole. With help from **Glynn County Fire Rescue**, the **Glynn County Police Department**, and the **United States Coast Guard Auxiliary**, this element of the museum's historic 60-foot flagpole was quickly repaired.
